CAFO FACILITY INSPECTION REPORT

<u>8365986001</u> WDID NUMBER	<u>Pat Carrigan</u> OWNER NAME	<u>American Beef Packers</u> FACILITY NAME
<u>CAG018001</u> NPDES NUMBER	<u>Ex. 6 Personal Privacy (PP)</u>	
<u>R8-2007-0001</u> RWQCB ORDER NO.	<u>Chino, CA 91710</u> OWNER CITY AND STATE	<u>Ontario, CA 91762</u> FACILITY CITY AND STATE
<u>03-06-2013</u> SCHEDULED INSPECTION DATE	<u>Pat Carrigan</u> OWNER CONTACT	<u>Sam Sousa</u> FACILITY CONTACT
<u>03-06-2013</u> ACTUAL INSPECTION DATE	<u>Ex. 6 Personal Privacy (PP)</u>	
<u>Unknown</u> RECEIVING WATER	<u>Ex. 6 Personal Privacy (PP)</u>	
	FACILITY LATITUDE	FACILITY LONGITUDE

REPORT PREPARED BY: Anthony D'Angelo (PG Environmental, LLC) ON 03/14/2013

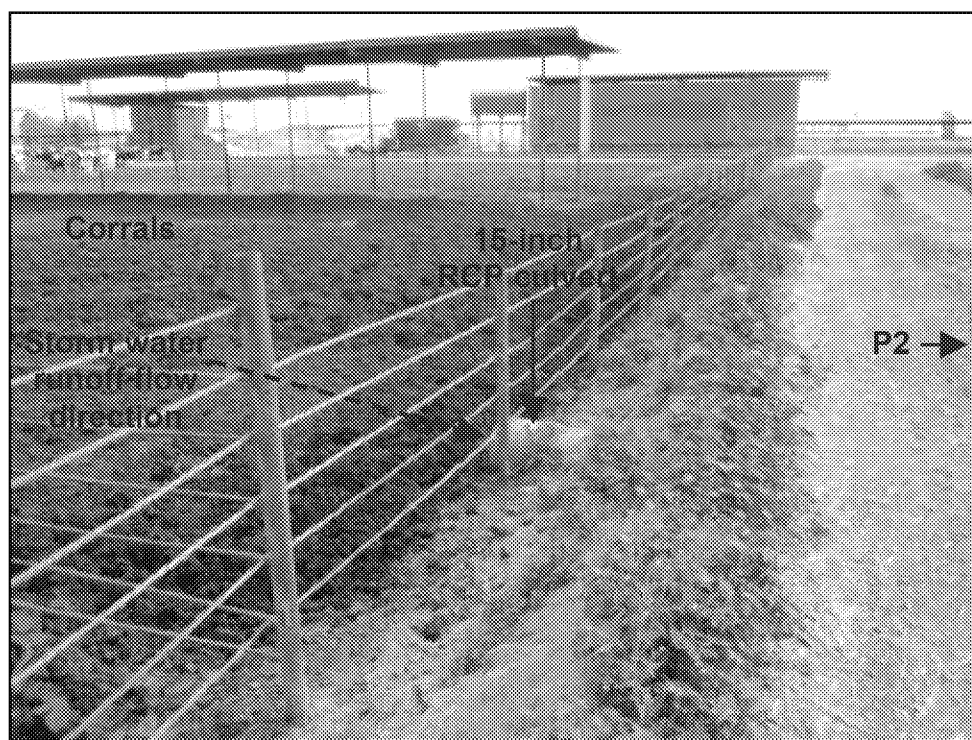
Photograph 11. View facing east of the 15-inch Reinforced Concrete Pipe (RCP) culvert which conveys storm water runoff from the corrals into P2.

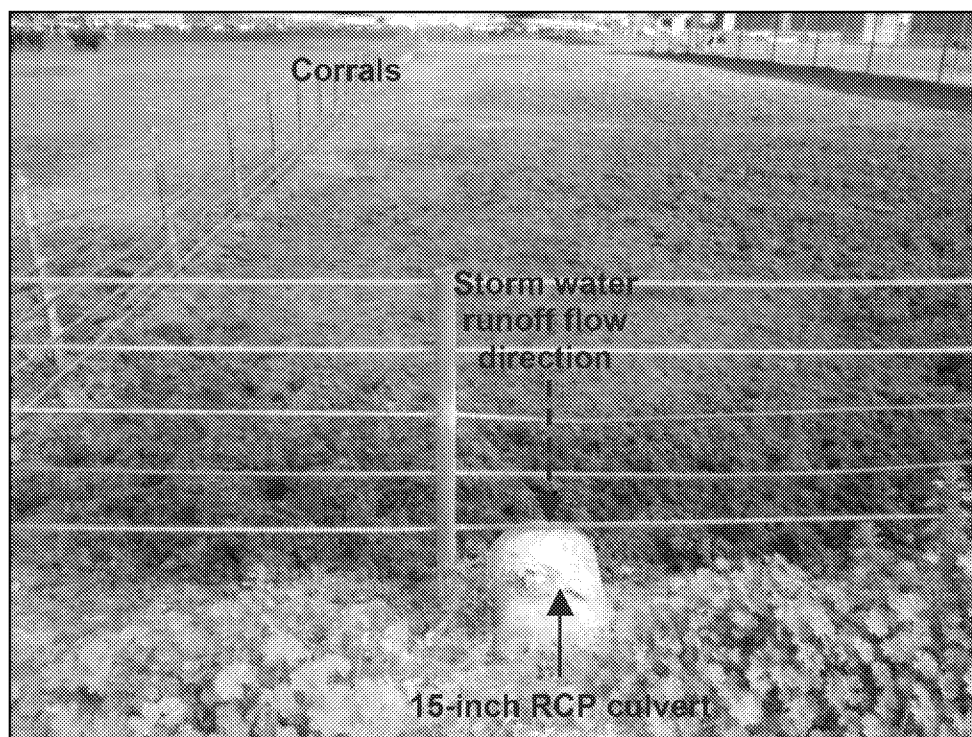
Photograph 12. View facing north of the 15-inch RCP shown in Photograph 11. Note this culvert conveys storm water runoff from the corrals into P2.

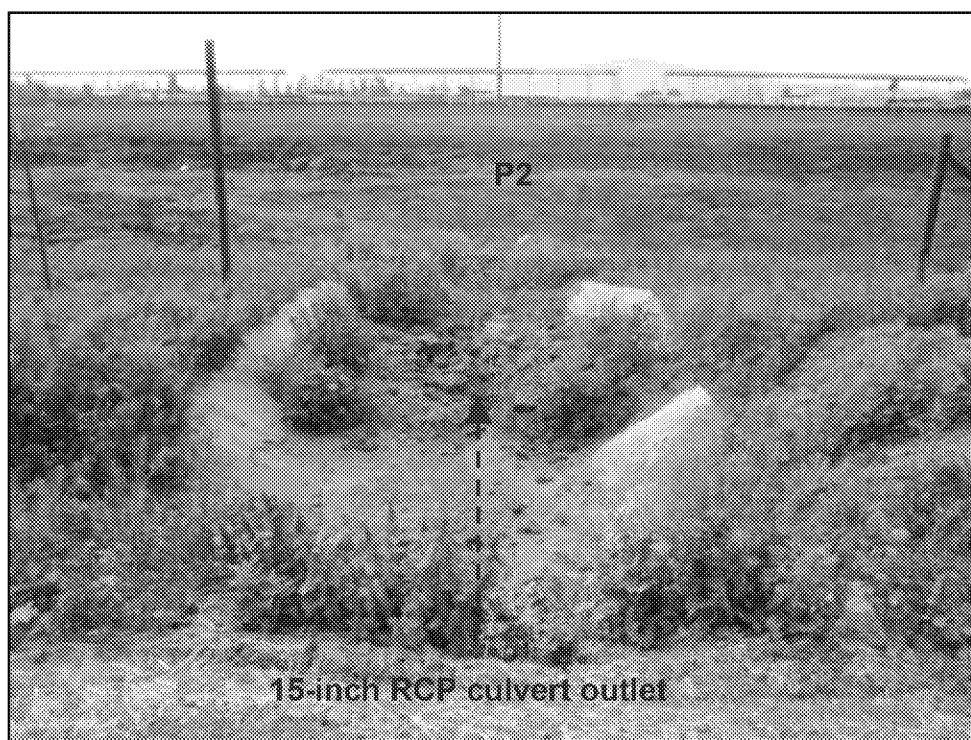
Photograph 13. View facing south of the 15-inch RCP culvert outlet into P2. Note this culvert conveys storm water runoff from the corrals into P2.

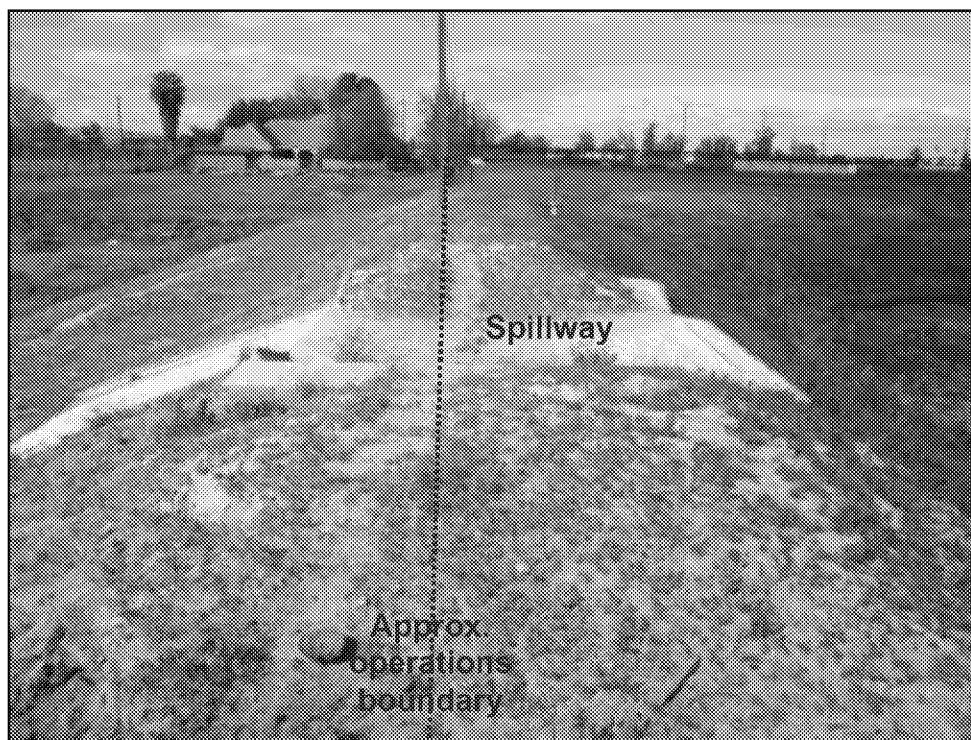
Photograph 17. View facing west of the concrete spillway on the south side of P1.
